Sam Slick Park

Shoreline Restoration Plan

Final Draft Report

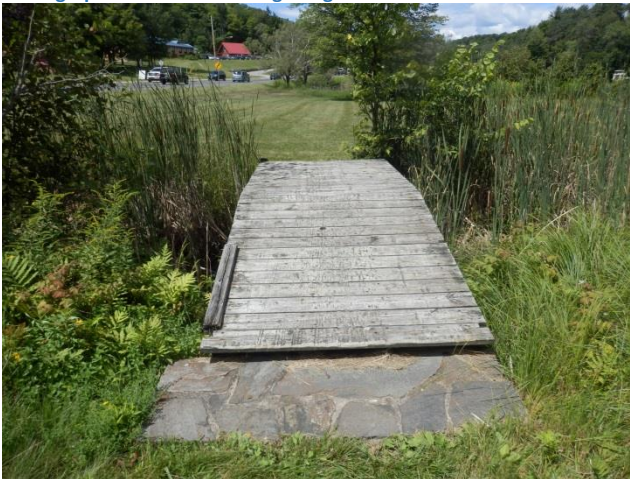
Sam Slick Park is a 0.27 ha park fronting onto Head Lake with approximately 110m of shoreline. The property is maintained as an open area for public use through regular lawn maintenance (See Photograph 1 and Photograph 2). Originating from south of County Road 21, a stream bisects the property and flows northerly into Head Lake. A walking bridge has been constructed over the stream to facilitate access from one side of the park to the other (See Photograph 3). The community and municipality have expressed interest in replacing the bridge. However, the bridge appears to be utilized by pedestrians and sleds and how this use is to be balanced requires a comprehensive review of the historical trends, objectives and implications of change. For example, tailoring the bridge to pedestrians only may increase the risk of collisions with traffic on County Road 21, yet it seems reasonable to assume that a dual purpose bridge also has associated risks. Bridge design, strength and safety are beyond the scope of this project.

Photograph 3: Wooden walking bridge over the stream

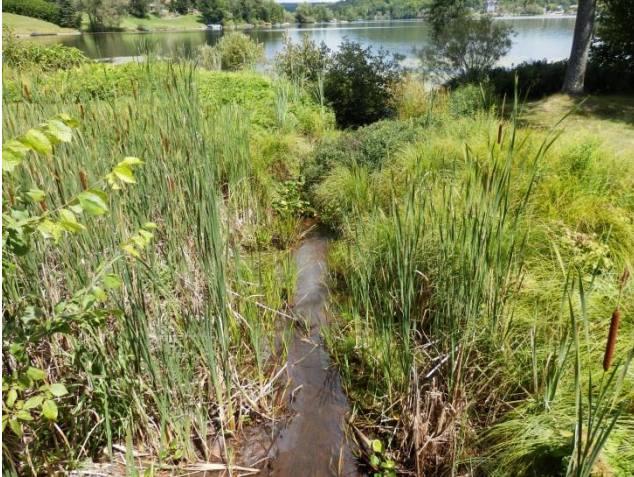
Photograph 5: Stream with vegetated buffer

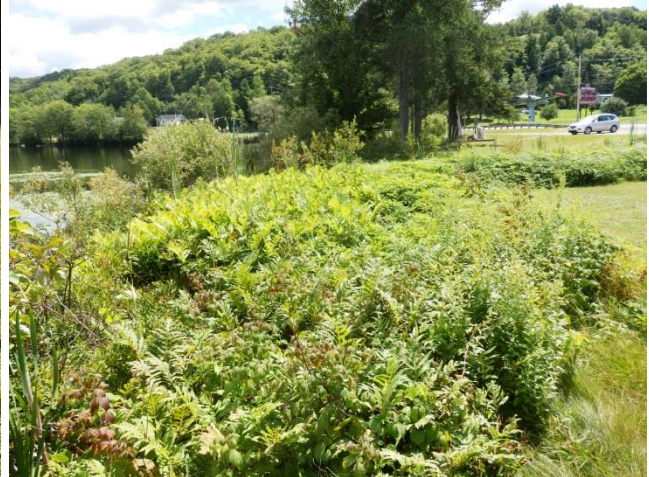
Photograph 6: Vegetated buffer along shoreline

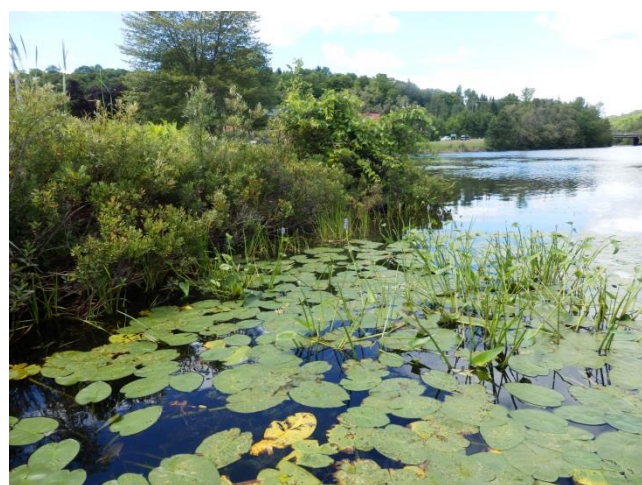
Aquatic vegetation provides valuable fish habitat and can help protect the shoreline from erosion caused by wave action. Emergent plant species, particularly robust emergents, provide the greatest protection whereas submergents and floating plants have less of an effect. Glenside Ecological Services Limited assessed the presence of aquatic plants in 10m intervals beginning at the northwest edge of the Park (See Table 2 and Photograph 7).

Emergent vegetation was limited to small patches or thin bands along the shoreline and never exceeded 5% coverage. Broad-leaved and narrow-leaved cattail (*Typha latifolia* and *Typha angustifolia*), broad-fruited burreed (*Sparganium eurycarpum*), pickerelweed (*Pontederia cordata*) and sedges were all noted in this component.

Photograph 7: Floating and emergent aquatic plants in Head Lake

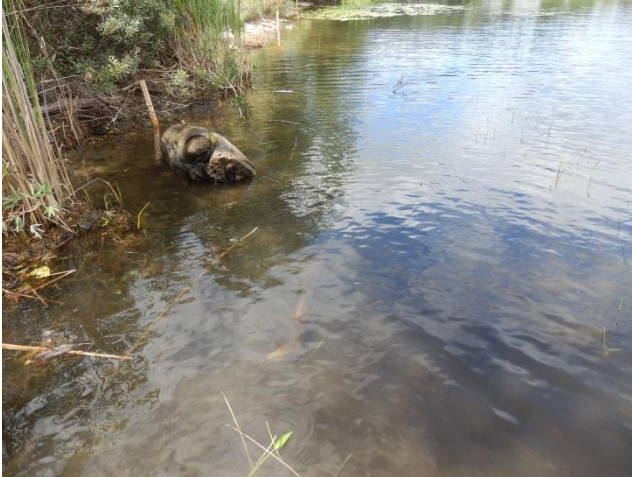
Photograph 8: Partially submerged log

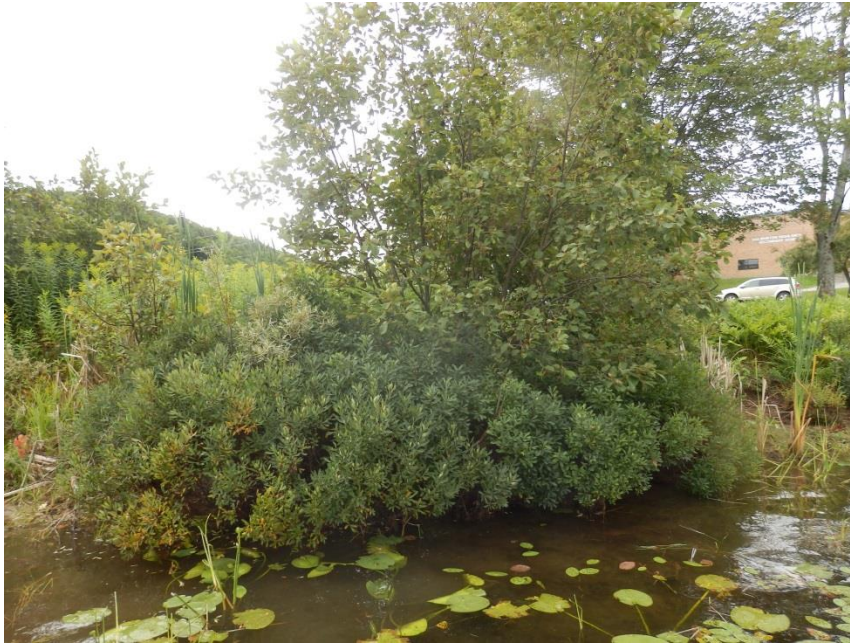
Zones 1, 3, 7 and 8 represent the healthier zones along the shoreline of Sam Slick Park. In these zones the upland vegetation buffer widths range from 2.30 m to 6.20 m with additional overhanging shrubbery ranging from 0.55 m to 2.80 m (See Table 4, Photograph 9 and Photograph 10). Submerged, floating and emergent aquatic vegetation can be found throughout much of the shallow waters fronting these zones. Bank profiles are moderate with a maximum height of 0.70 m and maximum slope of 35° (See Table 5) The combined length of Zones 1, 3, 7 and 8 is 41.2 m.

Photograph 9: Floral structure of shoreline in Zone 3

Although Zones 1, 3, 7 and 8 represent the healthier zones along the shoreline of Sam Slick Park, the existing vegetative buffer still requires some enhancement in the upland area. The existing upland buffer ranges from 2.30 to 6.20 m in width. Typically, recommended buffer widths for bank stability, nutrient reduction, and wildlife habitat are at a minimum of 20-30 m (Muskoka Watershed Council, 2013). As the width of Sam Slick Park at its widest point is only 30 m from the high water line, the development of a 30 m buffer would compromise the function of the Park. That said, any expansion of the existing buffer would be considered an improvement to meeting those functions. Therefore, Glenside Ecological Services Limited recommends expanding the existing vegetation buffer to a consistent 6.0 m in width. A 6.0m buffer width is of sufficient size to support floral structure and deter random access to the lake, while still providing a park area and not encroaching on the park features (i.e. monument).

As well as expanding the width of the vegetative buffer, Glenside Ecological Services Limited also recommends enhancing the floral structure of the buffer to create a multi-layered buffer consisting of trees, shrubs and herbaceous plants. These zones typically have sufficient aquatic vegetation and bank shrubbery but the upland floral structure is lacking. Planting of upland shrubbery is recommended.

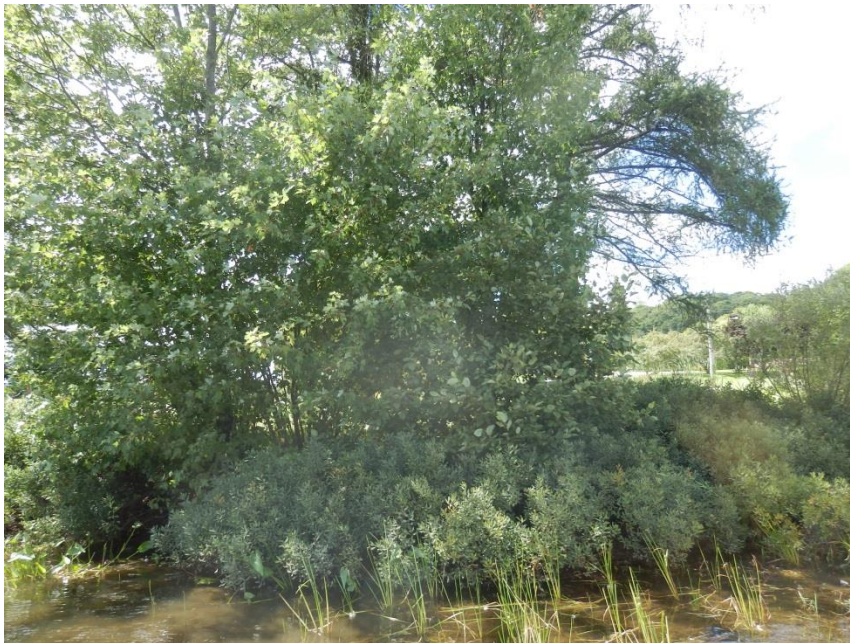
Photograph 10: Floral structure of shoreline in Zone 8

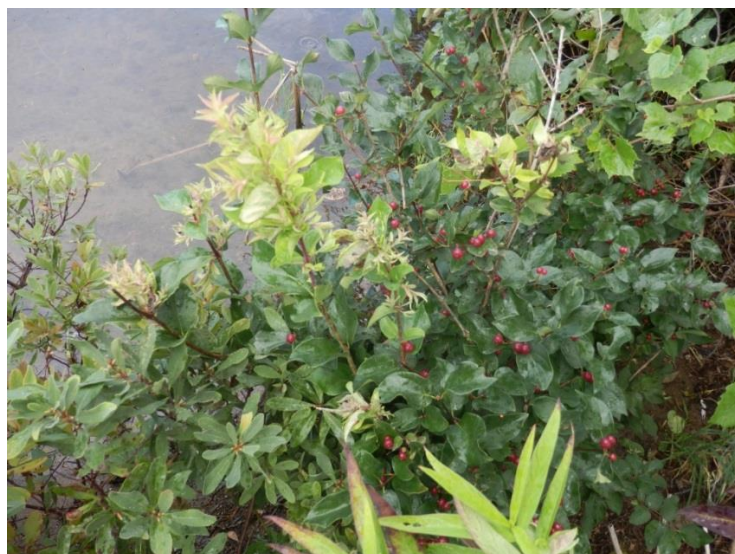
Photograph 11: Exotic honeysuckles located at northwest end of Zone 7

Currently the distribution of the exotic honeysuckle is extremely limited, consisting of one shrub in one location and therefore Glenside Ecological Services Limited recommends hand removing the shrub prior to seed dispersal in late summer/early autumn. The area should be inspected yearly to ensure that new shrubs are not emerging. Any newly established exotic honeysuckle shrubs should be removed immediately.

It is imperative that any invasive plant material removed is disposed of in a proper manner as negligence can result in the proliferation of exotic honeysuckles in new areas. It is recommended that exotic honeysuckles are not composted but rather discarded with the regular garbage (Ontario Federation of Anglers and Hunters/ Ontario Ministry of Natural Resources and Forestry, n.d.).

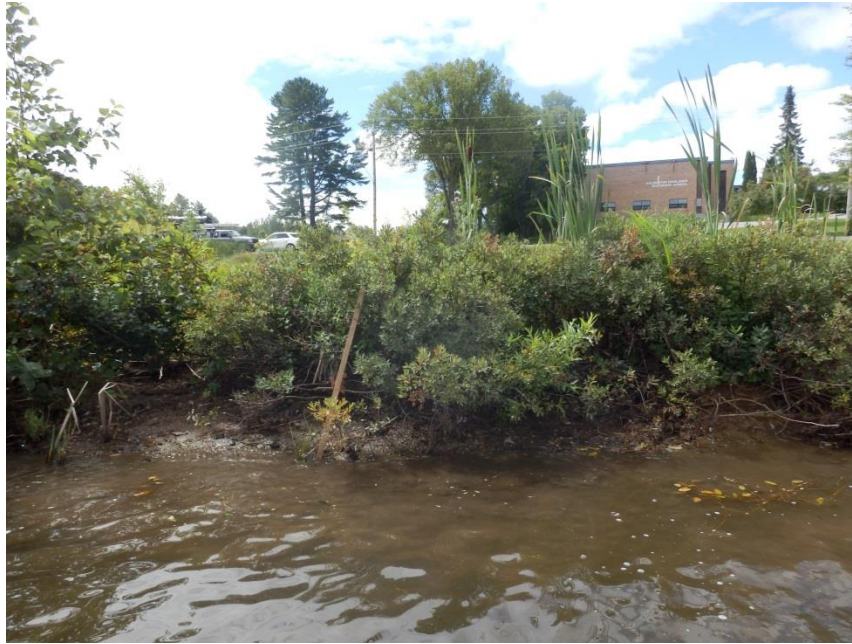
Photograph 12: Shoreline structure in Zone 6

Glenside Ecological Services Limited recommends expanding the width of the shoreline vegetation buffer to 6m, and enhancing the floral structure of the buffer to create a multi-layered buffer consisting of trees, shrubs and herbaceous plants. Specifically Zone 6 requires planting of upland shrubbery and tree species.

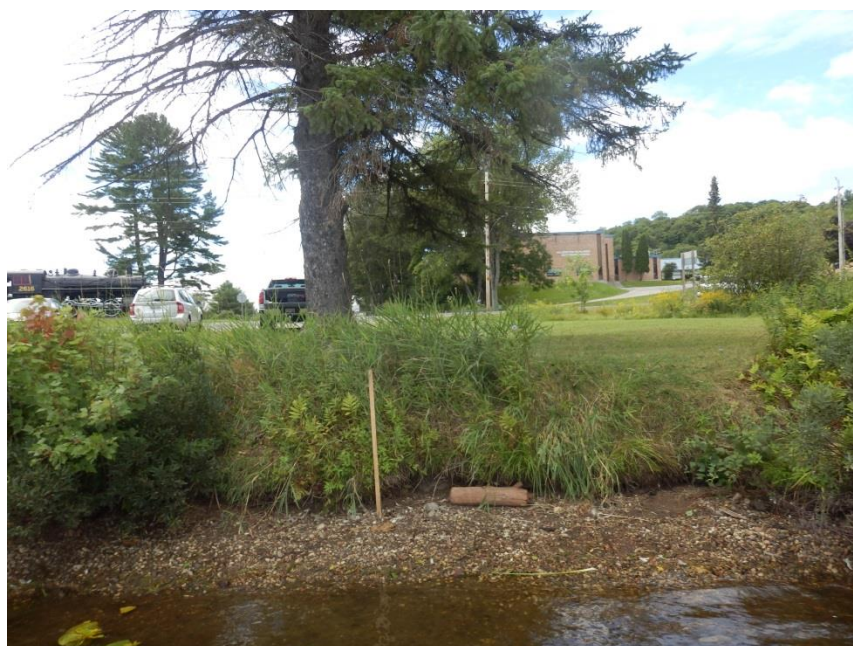
Photograph 13: Shoreline structure in Zone 10

Glenside Ecological Services Limited recommends expanding the width of the vegetative buffer to 6m, and enhancing the floral structure of the buffer to create a multi-layered buffer consisting of trees, shrubs and herbaceous plants. Specifically Zone 2, 4, 5, 9, 10, 11 and 13 require the planting of bank shrubbery, upland shrubbery and tree species.

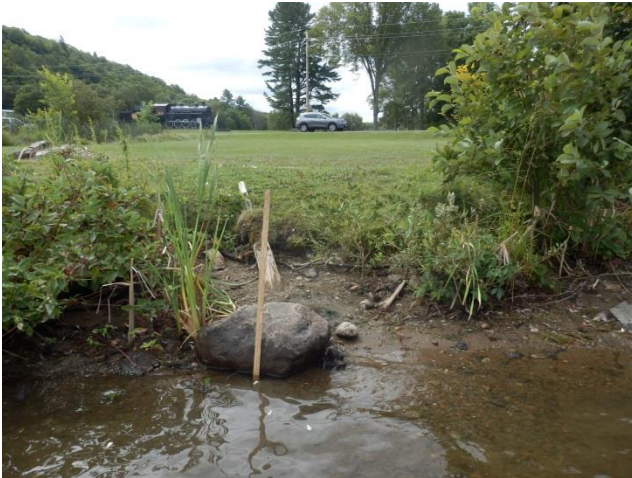
Photograph 14: Goose access point at Zone 5

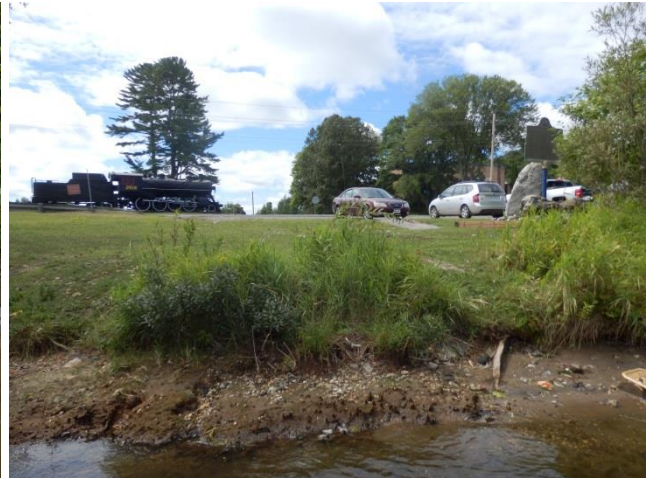
Photograph 15: Goose access point at Zone 11

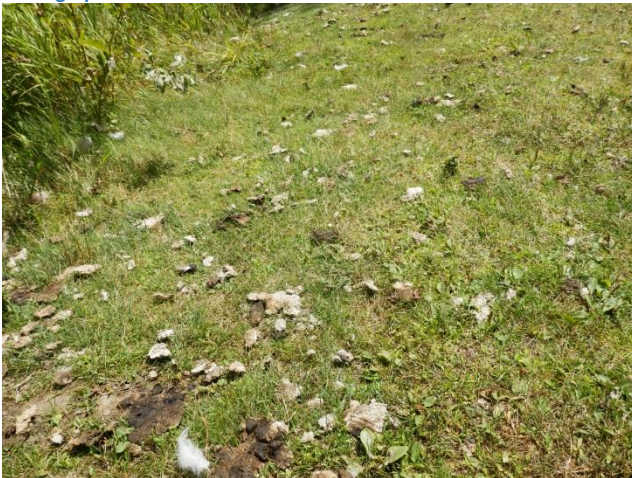
Photograph 16: Goose excrement at Zone 5

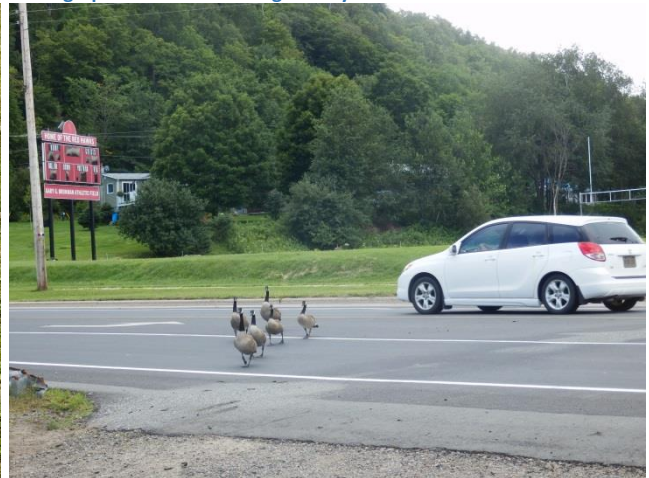
Photograph 17). This activity has become a traffic concern as evidenced by two near accidents witnessed by Glenside during the field investigation. A dead goose was also noted on County Road 21 as well as two others along the shoreline. Whether the latter two are a result of trauma from a motorized vehicle is unknown.

Photograph 17: Geese crossing County Road 21 towards Zone 11

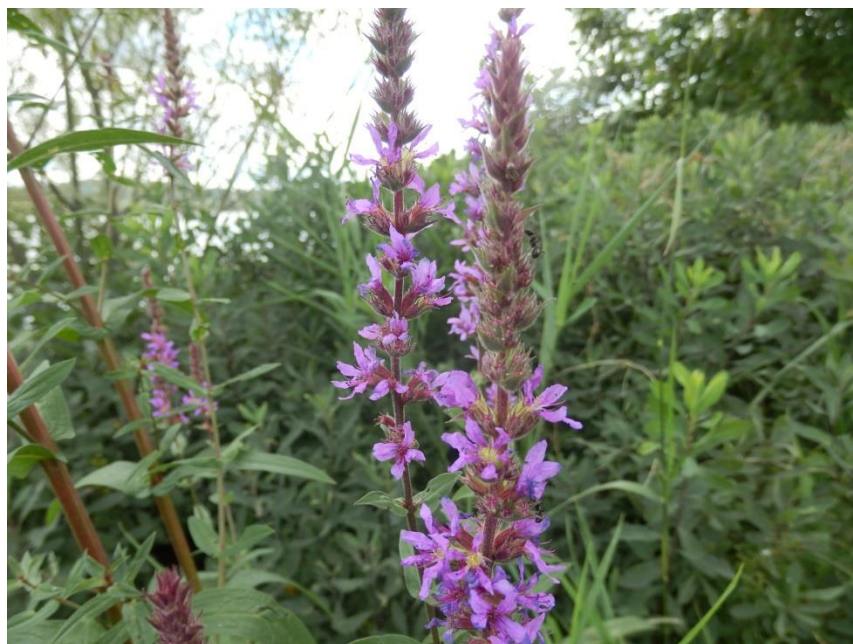
Three to five stems of purple loosestrife (*Lythrum salicaria*) can be found approximately 5 m from the northwestern end of Zone 13 (See Table 16, Photograph 18 and Figure 8). Purple loosestrife forms dense stands with thick root mats that can spread over large areas, degrading habitat for many native birds, insects and other species. By crowding out native plants purple loosestrife reduces the biodiversity along riparian buffers.

Photograph 18: Purple loosestrife (*Lythrum salicaria*)

Currently the distribution of purple loosestrife at Sam Slick Park is limited to three sites, consisting of less than 50 stems and therefore Glenside Ecological Services Limited recommends hand removing the plant before it goes to seed in late June, July and early August. If removing after plants with seeds, gently bend stalks over a plastic bag and cut them off to ensure seeds do not drop onto the ground during removal. Remove as much of the root system as possible as broken roots may sprout new plants. The area should be inspected yearly to ensure that the new plants are not emerging. Any newly established purple loosestrife should be removed immediately.

It is imperative that any plant material removed is disposed of in a proper manner as negligence can result in the proliferation of purple loosestrife in new areas. It is recommended that purple loosestrife is not composted but rather discarded with the regular garbage (Ontario Federation of Anglers and Hunters).

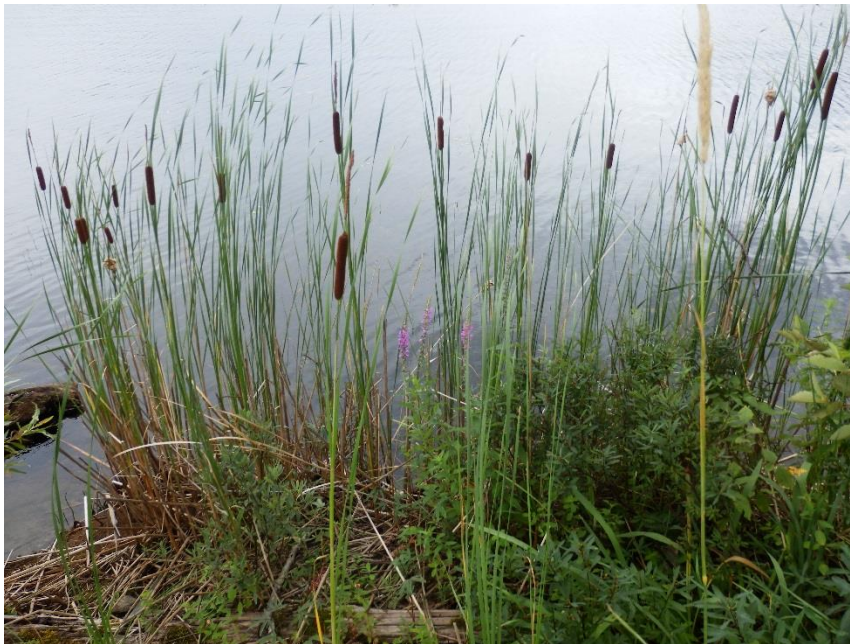
Narrow-leaved cattail (*Typha angustifolia*) is distributed along the shoreline and streambanks of Sam Slick Park and is considered to be an exotic plant in Ontario (See Photograph 19). Hybridizing with common cattail to form *Typha glauca*, this hybrid is extremely aggressive and will often outcompete either parent. Cattails in general can out-compete other native plants in disturbed areas, often forming monotypic stands of dense cattails (United States Department of Agriculture, Natural Resources Conservation Service, 2015).

Photograph 19: Narrow-leaved cattail (*Typha angustifolia*)

Although narrow-leaved cattail is considered an exotic plant, it is well established along the shoreline and streambanks and plays a critical role in stabilizing the banks, filtering sediments and deterring geese. Further the invasive tendency of cattails is in disturbed areas where the light fluffy seeds can become quickly distributed over bare soils. It is therefore the opinion of Glenside Ecological Services Limited that the removal of narrow-leaved cattail will be more damaging to the site then retaining the plants. No action is recommended.

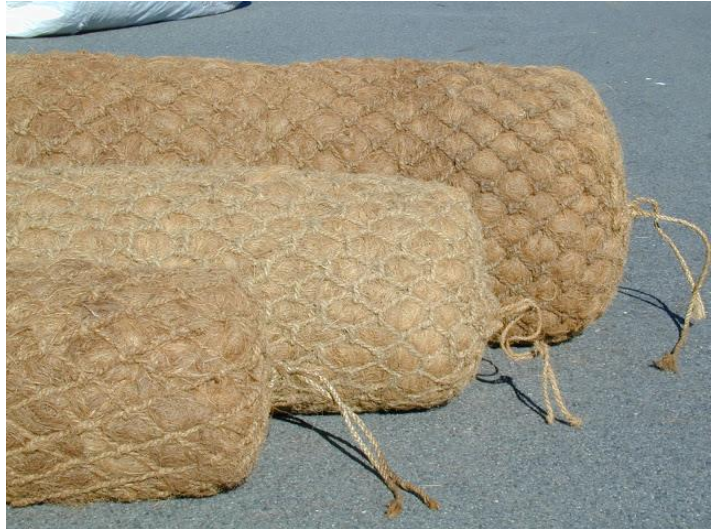
Coir logs are manufactured from 100% biodegradable coconut fibres and provide immediate and temporary toe of slope protection while plants and root networks become established. At 2.28 m in length, 30 cm in diameter, and a weight of approximately 25 kg, they are relatively easy to manage and install. Coir logs have a functional longevity of 3 to 4 years.

Photograph 20: Coir Logs

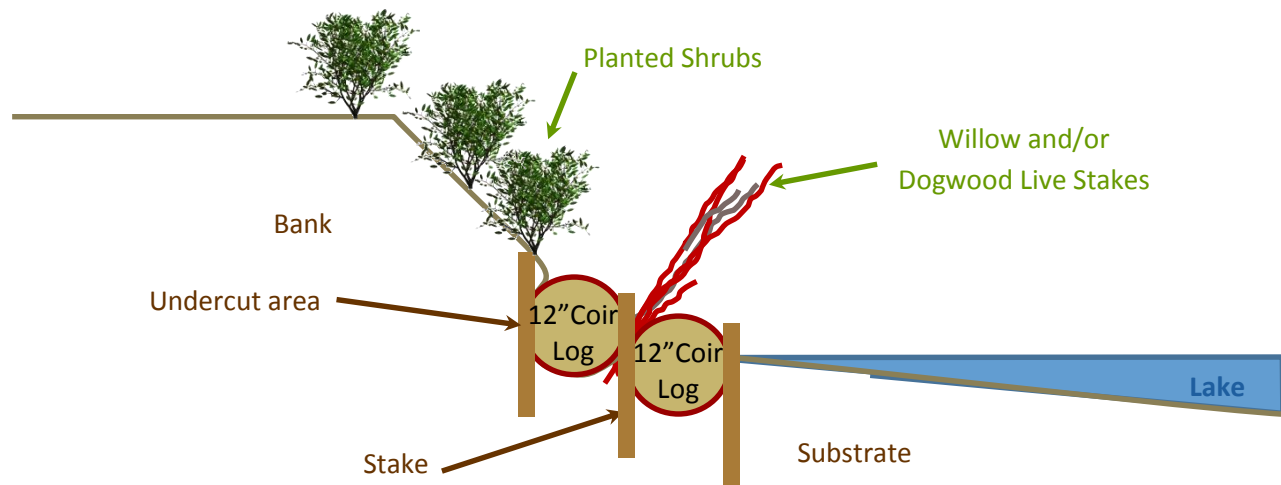
Figure 5: Mitigation with coir logs at Zones 9, 10 and 11

Zones 9, 10 and 11 offer the best opportunity to demonstrate the use of coir logs as a soft armour mitigation technique to stabilize the toe of the bank while establishing shrubbery.

To provide temporary toe of slope protection while bank plants and root networks become established, Glenside recommends placing one coir log directly into the undercut, fronted by a second coir log embedded in the substrate (See Figure 5). As the undercut is approximately 20-25 cm high, 30 cm (12") diameter coir logs will suffice. The coir logs should be staked into place using 8 stakes per log, with five stakes on the outside and 3 on the inside (Terrafix Geosynthetics Inc., 2013). Wooden stakes, 2" in diameter work well in substrates with low stone content (Klymko, 2015). The coir logs should be held down with twine attached to the stakes to ensure they are not lifted by wave and/or ice action, and the ends should be tied into the bank or other features to reduce wash-out potential. Adjacent logs should be tied together and further secured with river stone (Klymko, 2015). The river stone will not only help secure the ends of the coir logs but will also provide structure for fish habitat.

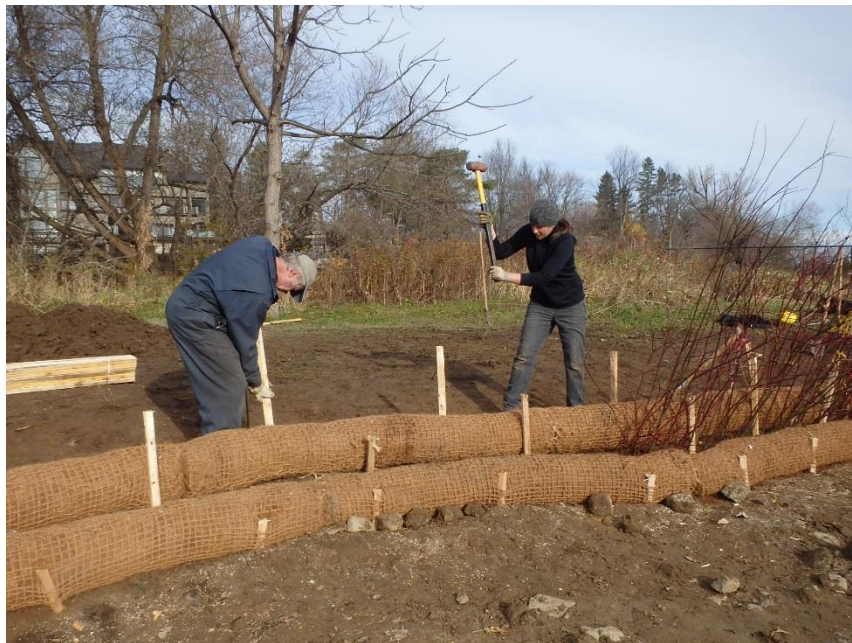
Photograph 21: Installation of coir logs by Rideau Valley Conservation Authority (Klymko, 2015)

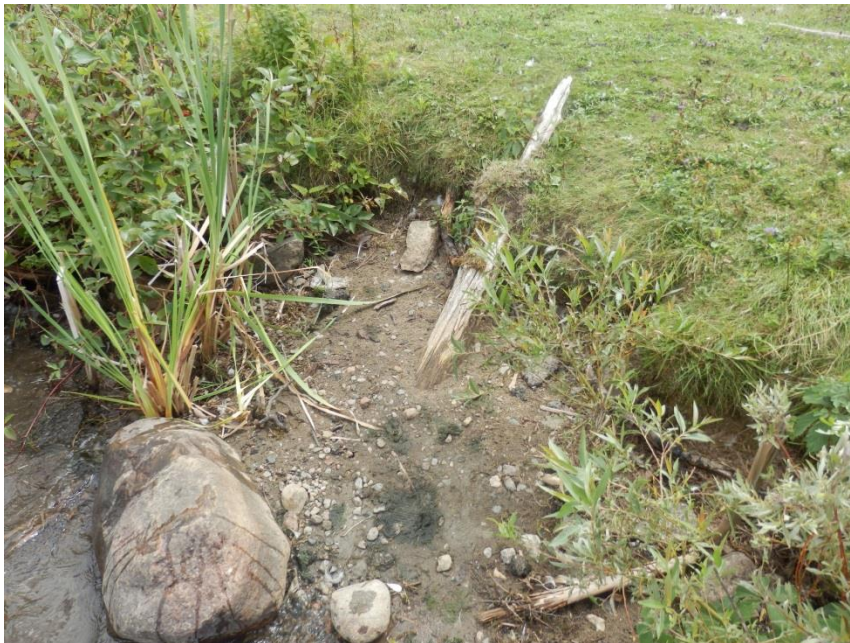
At Zones 5, 9, 10 and 11 there is evidence of mild undercutting resulting from a combination of wave action, and a lack of shoreline structural integrity due to a scarcity of shoreline vegetation. As the undercutting is mild it is anticipated that the establishment of a healthy shoreline vegetation buffer will likely suffice as a mitigation technique. However the objective of the COHPOA in remediating the shoreline of Sam Slick Park is to demonstrate a variety of effective mitigation techniques and the existing undercutting provides the opportunity to showcase the use of soft armour as a component of the solution. Specifically the placement of coir logs are an effective mitigation technique for undercutting on low profile banks as they absorb wave energy and allow vegetation to become established (Ontario Ministry of Natural Resources,

Photograph 22: Shoreline erosion in Zone 5

Zone 5 represents an opportunity to demonstrate a small scale stone revetment, which is a mitigation technique required for more severe erosion control. This technique would involve placing 30cm river stones at the toe of the bank to assist in stabilizing the bank. As the height of the bank is minimal in this area a stone revetment of 2-3 stones will be sufficient with the lower stone embedded into the substrate to deter undercutting. A medium sized rounded stone and embedded log currently can be found at this site (See Photograph 22). Glenside recommends incorporating these existing natural materials and allowing vegetation to grow up in between the rocks to provide a more natural setting. As some of the stones will be placed below the high water line, a permit will be required from Ontario Ministry of Natural Resources and Forestry.

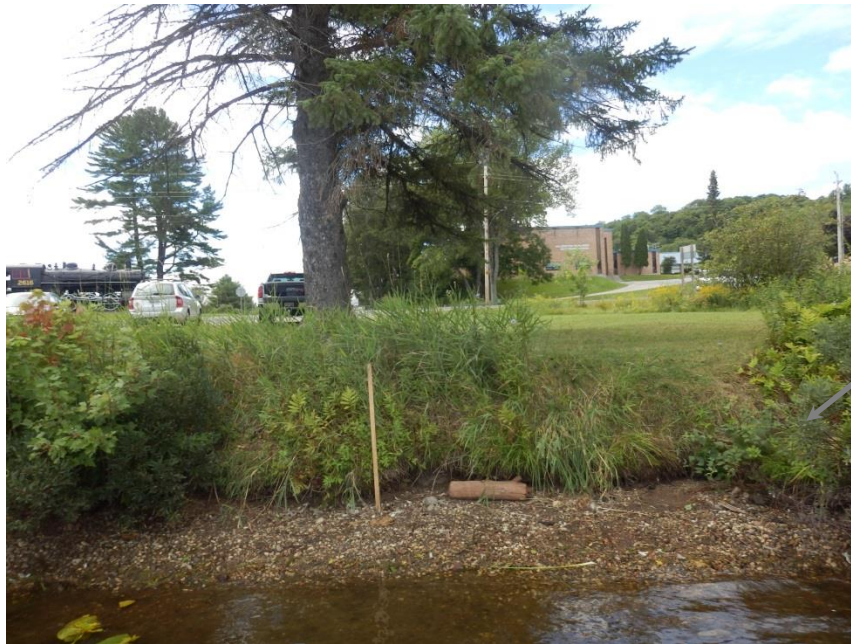
The second access point is located at the northwest end of Zone 9 (See Photograph 23). This access point consists of a vegetated clump that has been used as a standing spot, possibly for fishing or viewing the lake. To access this point Glenside recommends adopting the same trail and stepping stone layout as that proposed for Zone 5, with the exception of the water's edge where a larger stone (75cm x 45cm) is recommended as the bank is higher. As the larger stone will be placed below the high water line, a permit will be required from the Ontario Ministry of Natural Resources and Forestry.

Photograph 23: Access point in Zone 9

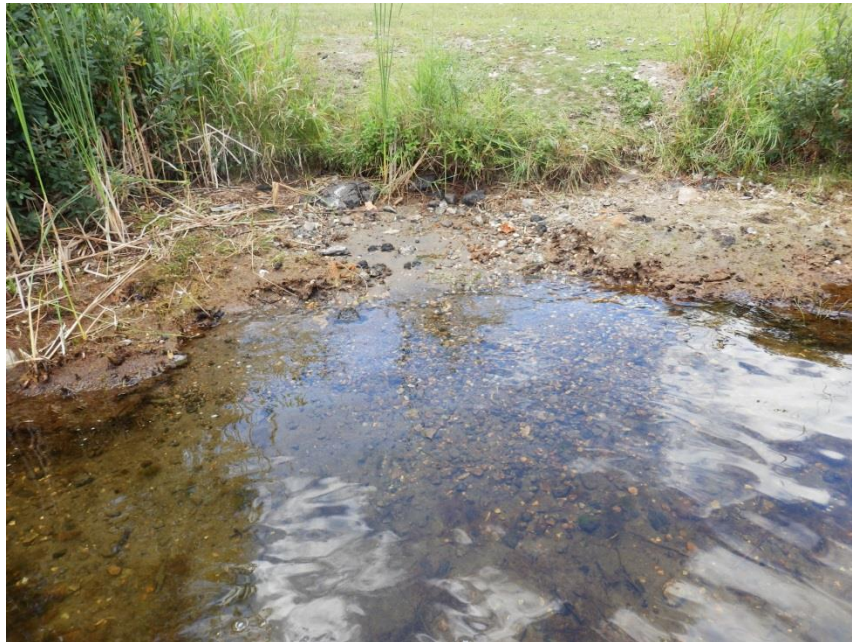
Photograph 24: Skidoo access point at Zone 12

Glenside Ecological Services Limited recommends the placement of large flat stones (roughly 1 m wide by 30 cm deep) to create a 6 m long ramp extending 3 m above and below the high water mark. Below the water line spaces between the stones should be filled with pea gravel to deter erosion and undercutting, however above the high water line the establishment of herbaceous plants and grasses between the stones

During the off winter months Glenside recommends installing and maintaining a barrier fence across the 2m zone to deter geese from using the zone as an access point. The fence should exceed adult/gosling height and be constructed in a manner that would prohibit geese from walking or seeing around, under or through it. As Canada geese can exceed 1m in height a 1.2m high fence is recommended. The fence posts should be placed at a safe distance from the ramp to reduce risk of snowmobiles colliding with the posts. Taller coniferous trees should also be planted around the fence ends to deter geese and people from circumventing the fence. These taller coniferous trees have been budgeted into the cost estimates for Zones 11 and 13.

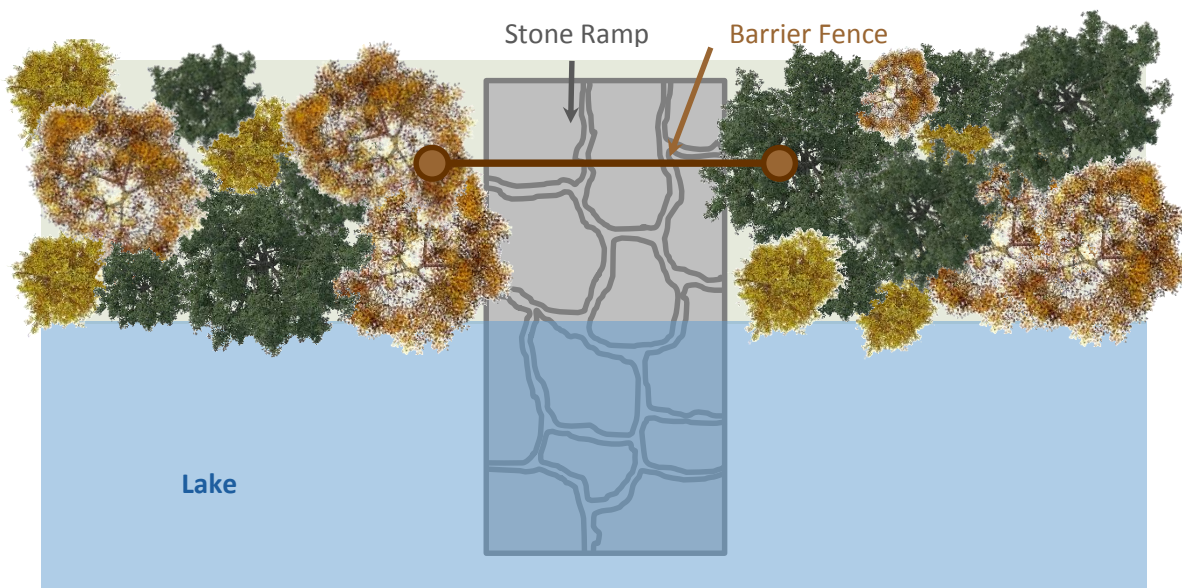
Figure 7: Skidoo access point sketch

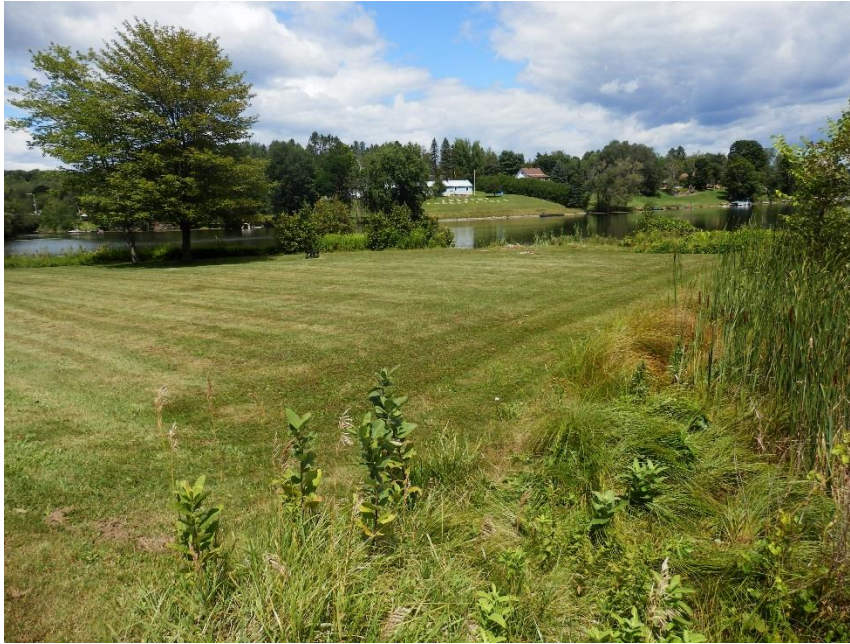
Zone 15 represents the upland open area of Sam Slick Park (See Photograph 25). This area is predominantly a managed grass area with a few scattered trees near the edges

Photograph 25: Open Area in Zone 5

Although the open park area associated with Zone 15 is beyond the scope of this shoreline restoration plan, it should be noted that efforts in Zone 15 can help assist with addressing issues related to the shoreline. Specifically, the open park area is a major attraction to the geese population, as geese prefer such areas for grazing purposes. The planting of trees throughout Zone 15 would create flight path barriers for the geese thereby making Zone 15 less desirable for grazing purposes.
